Manhole Inspection Summary

Manhole # S37AA1003MH

Location Address: **411 VENABLE AVE**

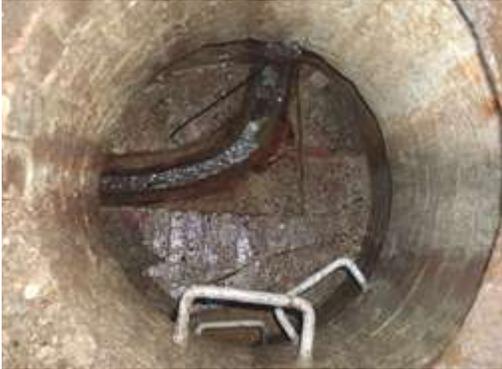
Top View

Bench debris.

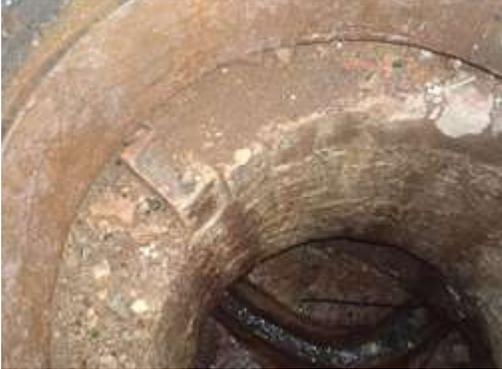
Defect

Frame leaks. Frame offset. Adjustment deterioration and infiltration.

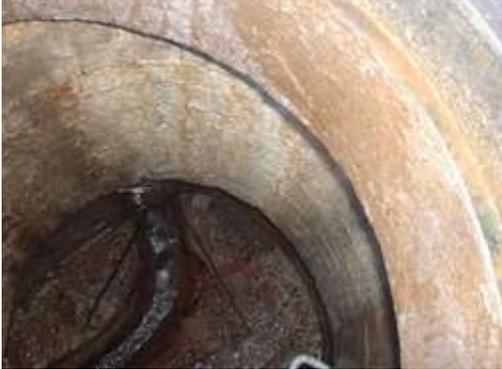
Defect

Frame leaks. Adjustment infiltration.

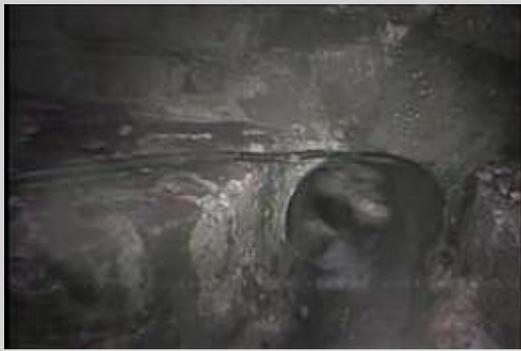
8 in. Circular Gravity Sewer
Pipe Out @ 12 O'Clock

Pipe Material: **Clay** Pipe Lined

Invert Depth: **7.97** (ft.) Flow Characteristics: **Slow**

Infiltration: **None** Pipe Seal Cond: **Unknown**

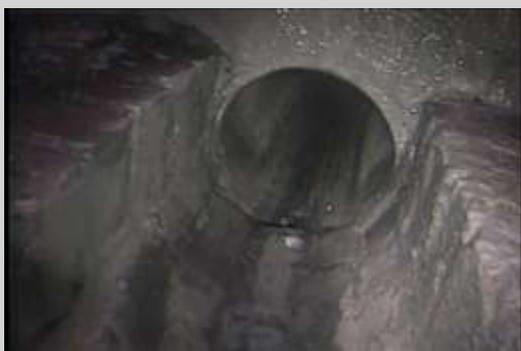
8 in. Circular Gravity Sewer
Pipe In @ 9 O'Clock

Pipe Material: **Clay** Pipe Lined

Invert Depth: **7.64** (ft.) Flow Characteristics: **Slow**

Infiltration: **Evidence** Pipe Seal Cond: **Sound**
